## MATERIALS FOR ADVANCED TURBINE ENGINES

### PROJECT COMPLETION REPORT PROJECT 1

# LOW-COST DIRECTIONALLY-SOLIDIFIED TURBINE BLADES

## VOLUME II

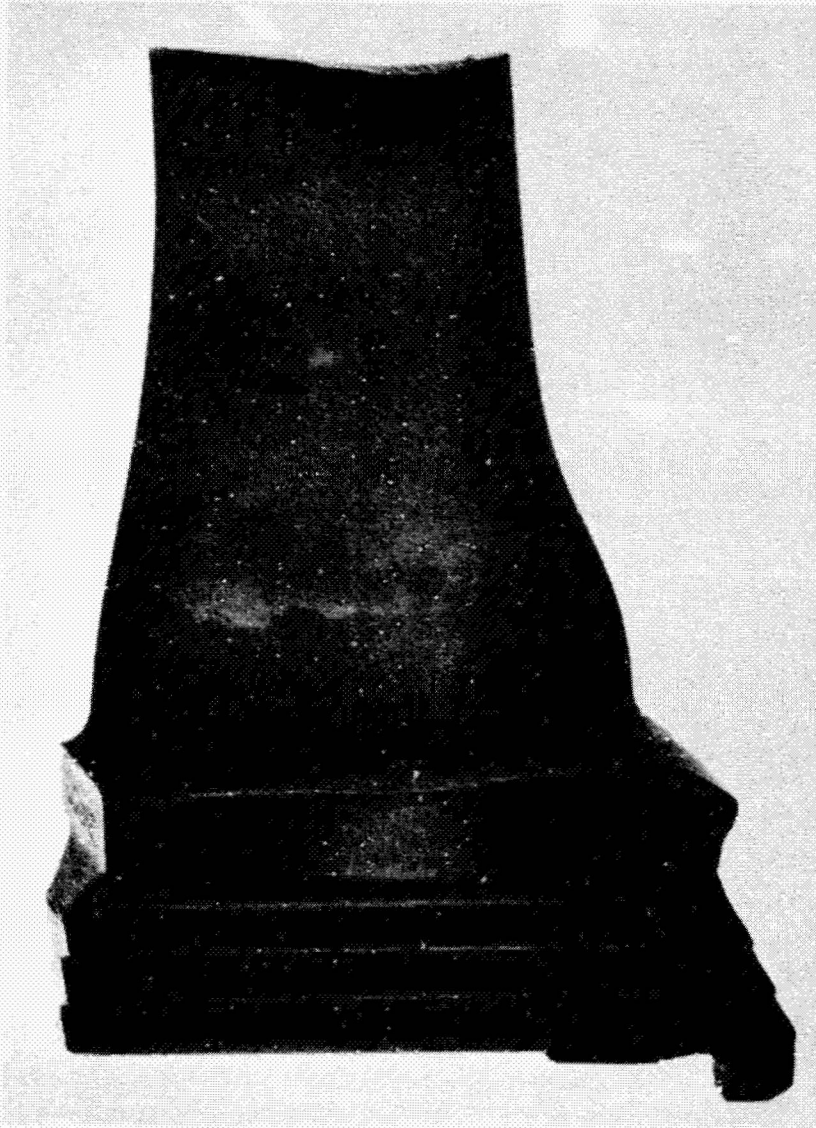
The tip-rub experience during the performance run removed approximately 0.015 cm (0.006 inch) from the tips of the tested blades. After disassembly and inspection of the engine, the rubbed blade tips were deburred to eliminate any sharp corners. No attempt was made to recoat the local areas near the rub zone

Figure 5. MATE DS Turbine Blade After Tip-Rub

prior to further testing. All new blades that were substituted into the disk were trimmed an equivalent amount to provide a uniform rotor-tip diameter. The wheel was assembled, balanced, and then installed in the engine. New shroud segments were procured with their chords trimmed 0.025 cm (0.010 inch) to allow for the additional circumferential thermal growths.

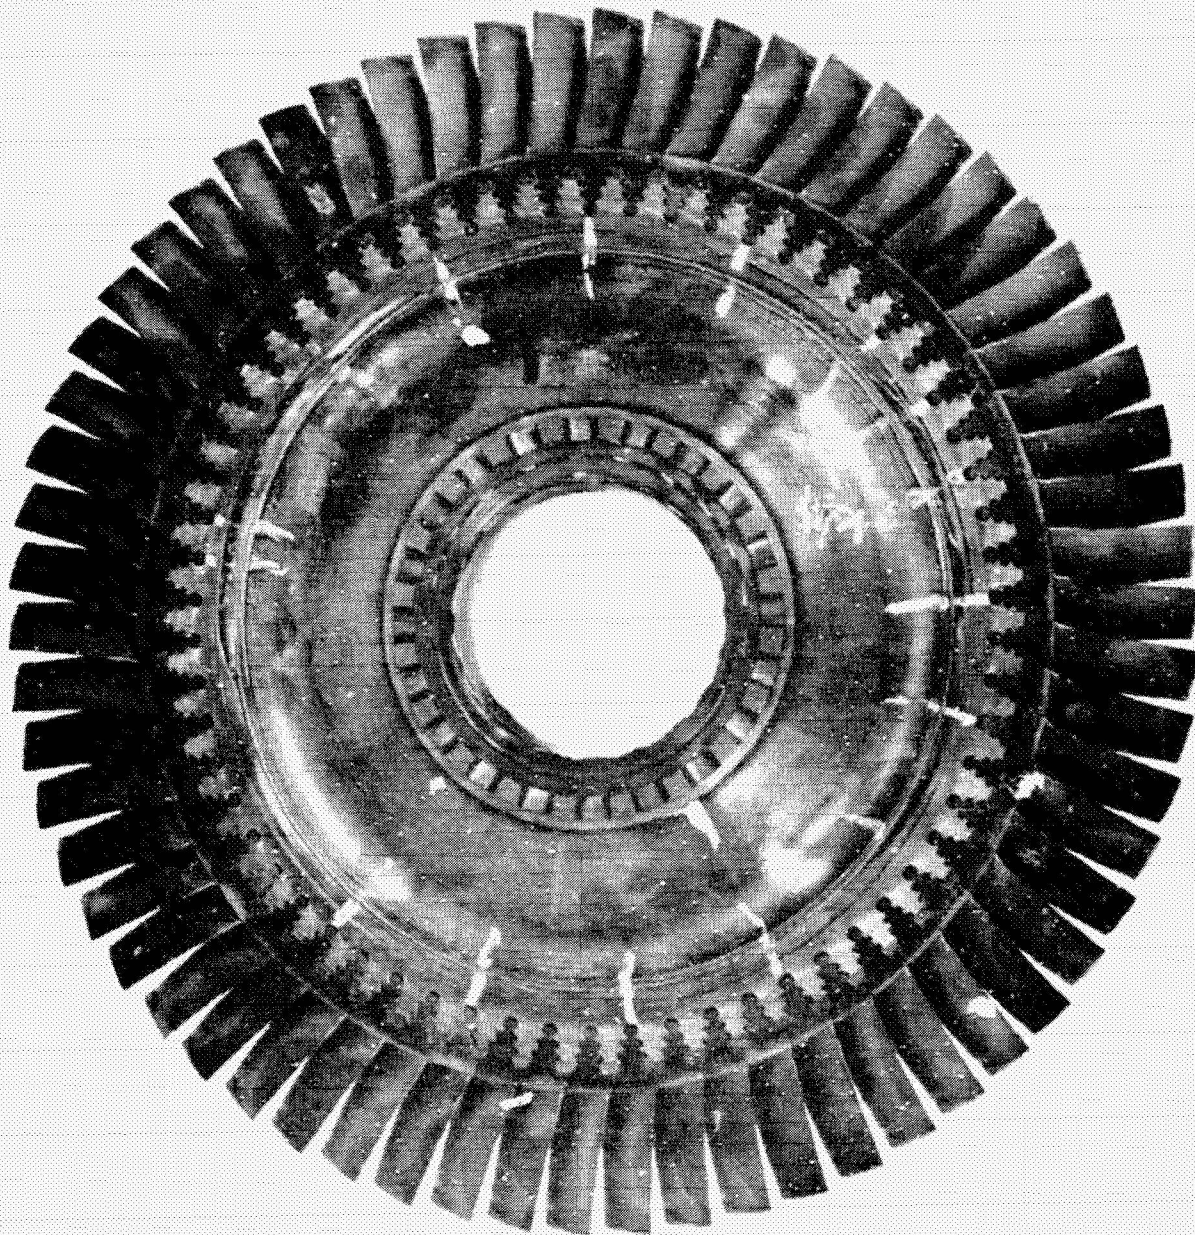
eliminated causing the shroud segments to run hotter. The clearance gaps between the shroud segments had not been increased to allow for the greater thermal expansion of the hotter individual shrouds. Thus, the shroud segments could not freely expand circumferentially, and local buckling occurred that forced the ends of two shroud segments to move radially inward. This buckling eliminated the blade-to-shroud clearance and caused a blade-tip rub. This rub, approximately 0.015-cm (0.006-inch) deep, removed the blade coating from the tips but did not result in any blade failures. The condition of a typical blade after the rub is shown in Figure 5. Figure 6 is a view of the complete rotor with the DS blades after the performance test.

Figure 6. High-Pressure Turbine Disk With DS Blades After the Back-To-Back Performance Tests (Note the Appearance of the Blade Tips )

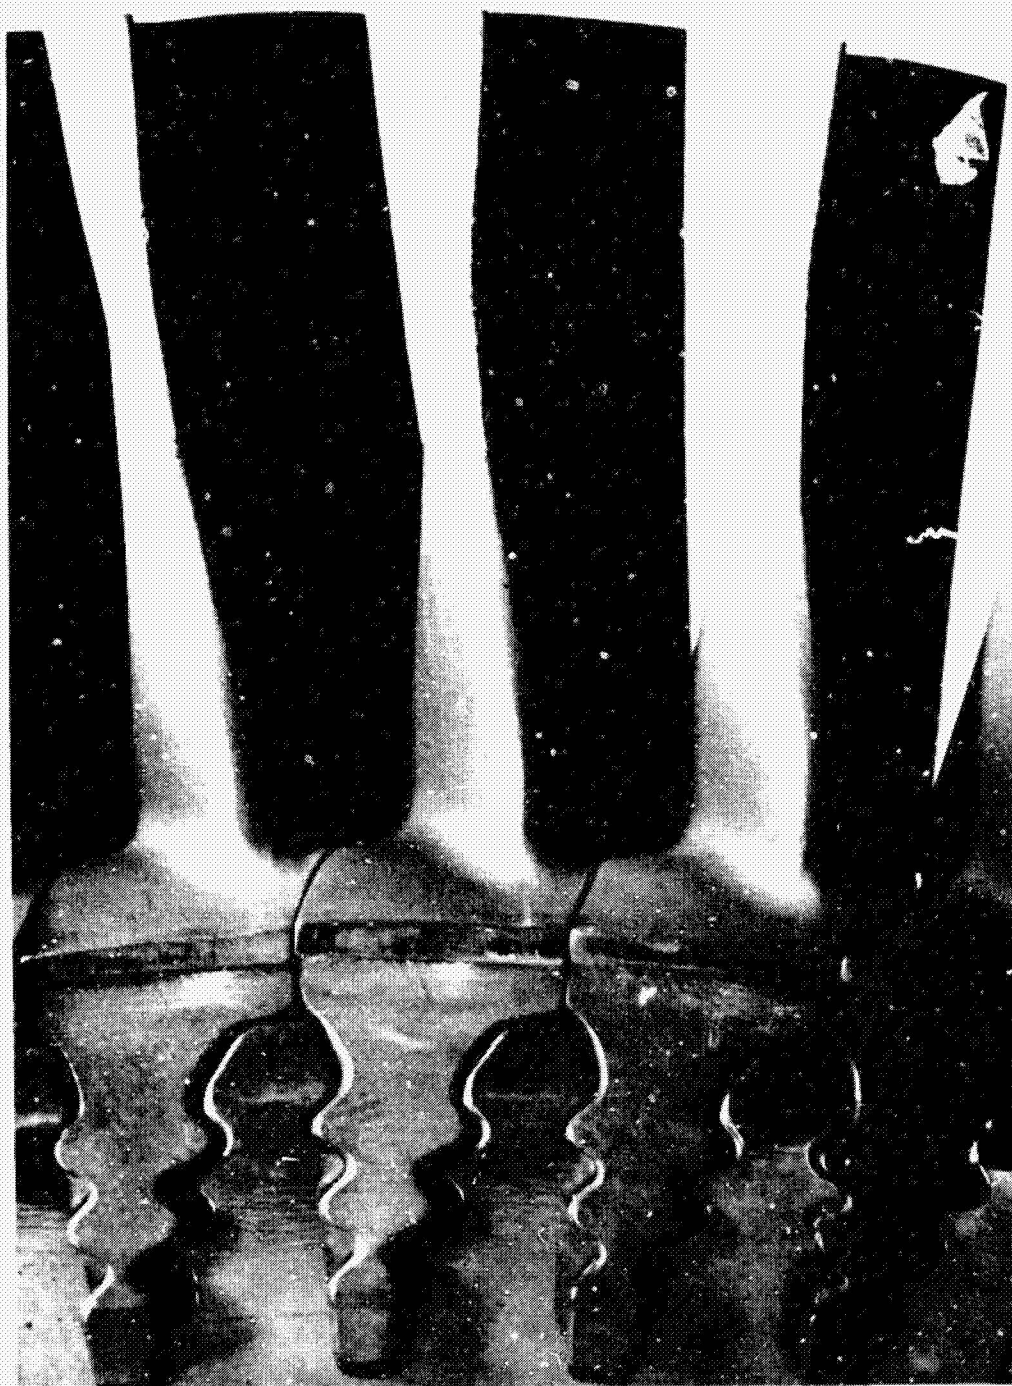
Figure 8. Leading-Edge View of Typical Blades Subjected to the Entire 150 Hours of Endurance Testing

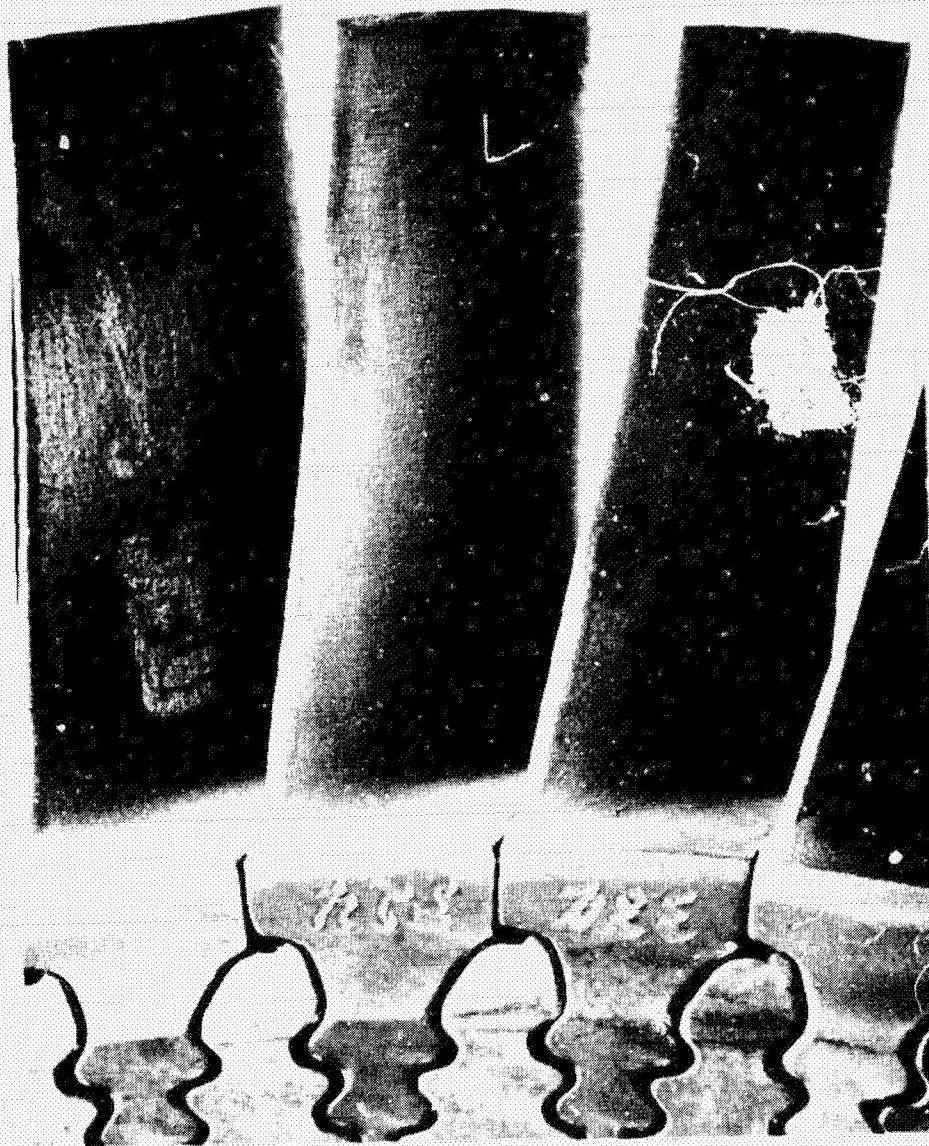
Figure 9. Trailing-Edge View of Typical Blades Subjected to the Entire 150 Hours of Endurance Testing

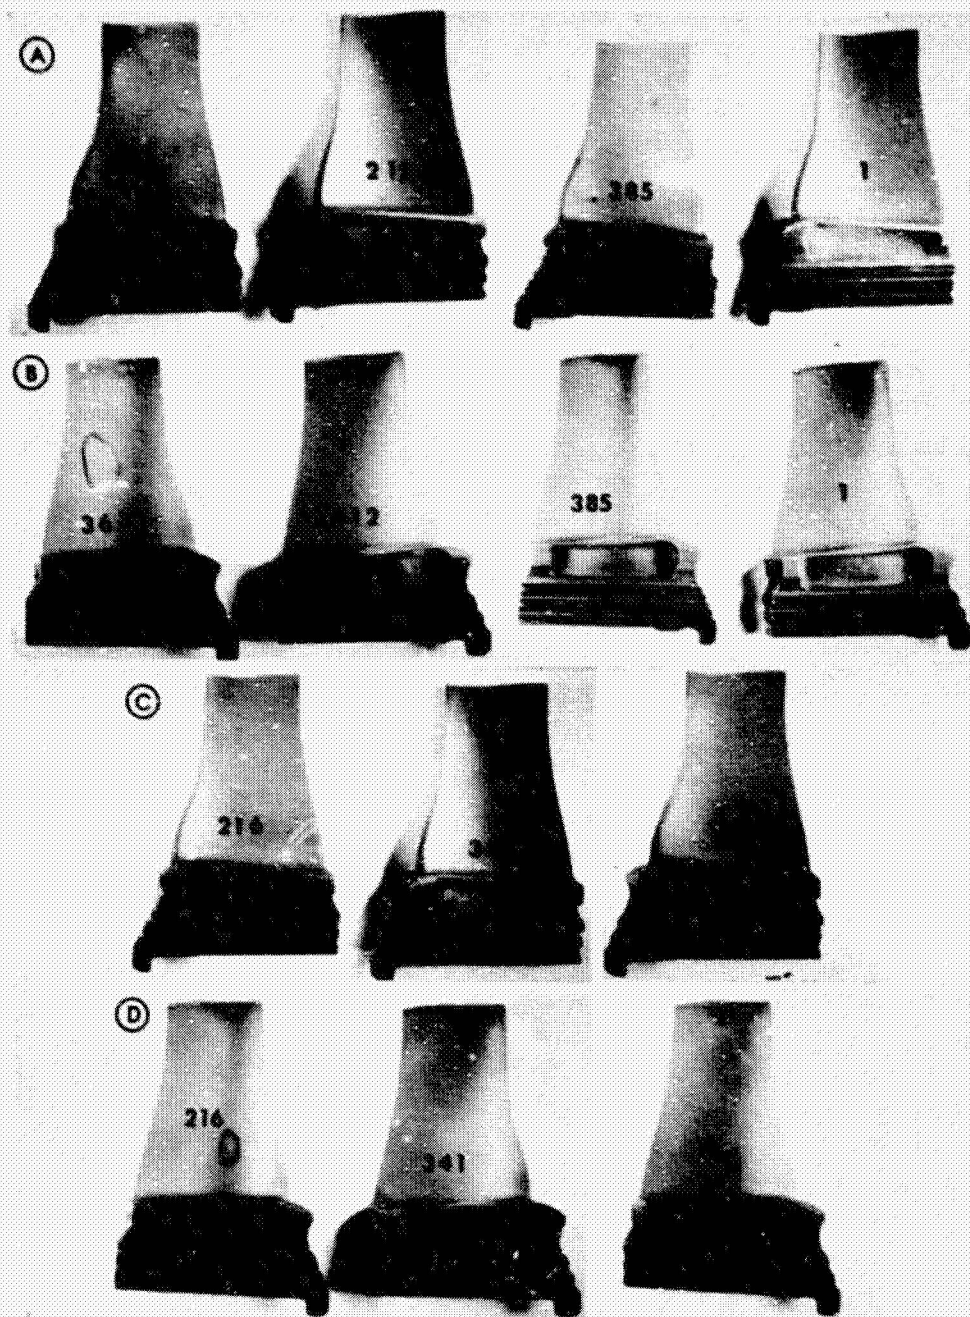
The serial numbers and the alloys of the blades selected for metallurgical evaluation are listed in Table III. Figure 10 depicts the seven blades selected for detailed examination after the third 50-hour test. The mark on the suction side of the blade S/N 367 identifies the area in which a 0.025-cm (0.010-inch) long coating crack was found. Inspection of this indication by binocular microscope at 40X magnification showed it to be a shallow crack within the coating and of no significance.

Figure 10. TFE731 MATE HP Turbine Blades After Engine Testing. The Numbers Denote the Blade Serial Numbers. Photos (A) and (C) Show the Pressure Side of the Blades, and Photos (B) and (D) Show the Suction Side (Mag.: 1X)

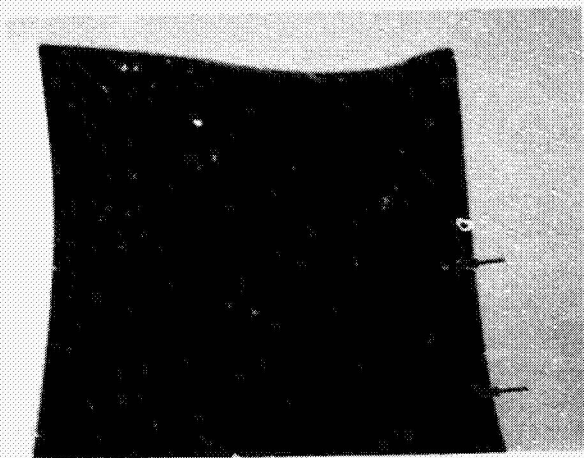
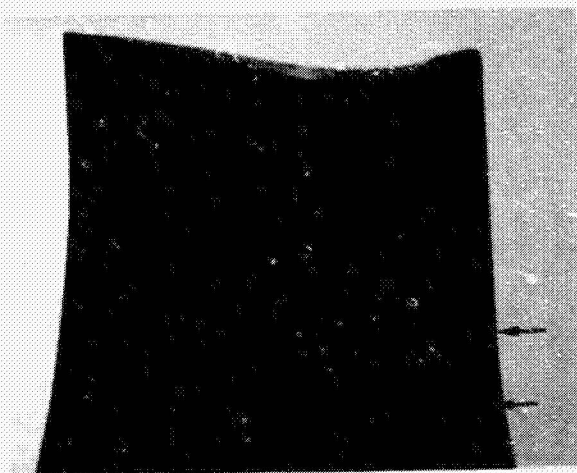
Although no extraneous deposits were found on any blades after the first 50-hour test segment, small white spots were noticed on all blades after the second and third test segments. These spots are shown in Photographs A and B of Figure 11. Figure 12 shows the areas sectioned to assess the microstructures of the seven blades and evaluate the small white spots.

Figure 11. Photomicrographs Showing Blade-Tip Rub Areas and the White Deposit on Blade Leading Edges. (a) MAR-M 200+Hf Blade S/N 13. (b) MAR-M 247 Blade S/N 341. The Arrows Indicate the White Deposit on the Leading Edges

SEM Energy Dispersive Analysis by X-ray (EDAX) of the white deposit on the leading edges of blades S/N 13 and 341, indicated that the spots were high in zirconium and magnesium (see Figure 16). An investigation revealed that the test engine utilized a plasma-sprayed, magnesia-stabilized zirconia thermal-barrier coating on the transition liner immediately forward of the high-pressure turbine. This coating had spalled in spots during the engine testing, and some material was deposited on the blade leading edges.

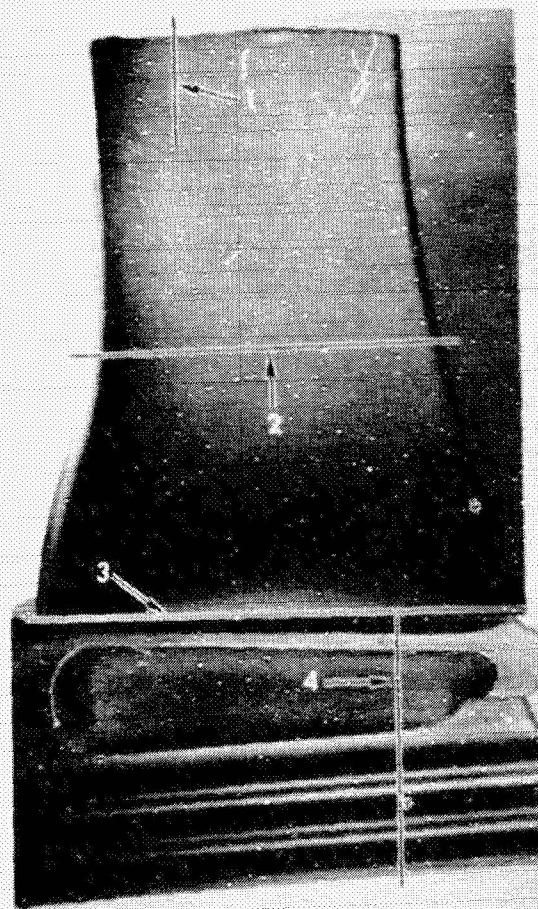
Figure 12. The Pressure Side of MAR-M 247 Blade S/N 341 Showing Microsection Locations. The Arrows Denote Sections: 1 - Blade-Tip Rub Area; 2 - Midspan; 3 - Airfoil Base; and 4 - Platform and Dovetail

Coating-thickness measurements were made at airfoil cross-sections located as shown on Figure 12. Ten measurements per section were collected and averaged, with the results reported in Table IV. All measured thicknesses were within the coating specification tolerance of 0.0025 to 0.005 cm (0.001 to 0.002 inch).

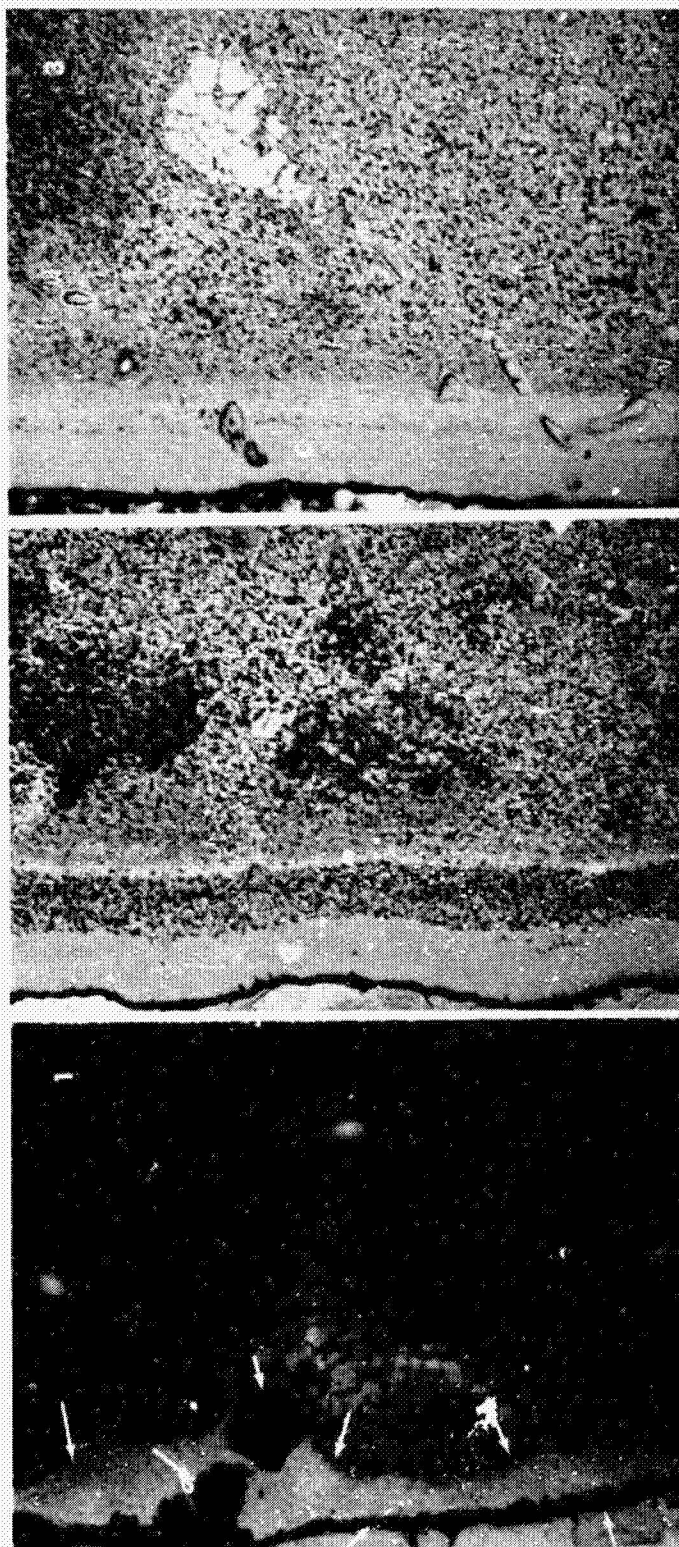
Figures 13 and 14 present typical microstructures of the DS blades--blade S/N 341 (MAR-M-247) and blade S/N 13 (MAR-M 200 +Hf), respectively. These blades suffered tip-rub damage during the performance test but were tested for the full 150 hours. As anticipated, oxidation and alloy depletion occurred at the tip where the coating was removed during the tip-rub, but other areas of the blades showed normal alloy and coating microstructures. More eutectic is evident in the MAR-M 200+Hf blade than the MAR-M 247 blade--probably due to the higher hafnium content of MAR-M 200+Hf alloy. Figure 15 presents the mid-span structure of four other engine-tested blades, both the alloy and coating structures are normal.

Figure 13. Representative Photomicrographs of MAR-M 247 Blade S/N 341. The Numbers Denote Sections Indicated in Figure 12. Section 1 is Through the Tip-Rub Damage Area Shows Alloy Depletion and the Oxidation; Section 2 Through the Mid-Span and Section 3 Through the Airfoil Base Show Normal Alloy and Coating Structures. The Letter C denotes Coating (Etchant: Oxalic Acid) (Mag.: 500X)

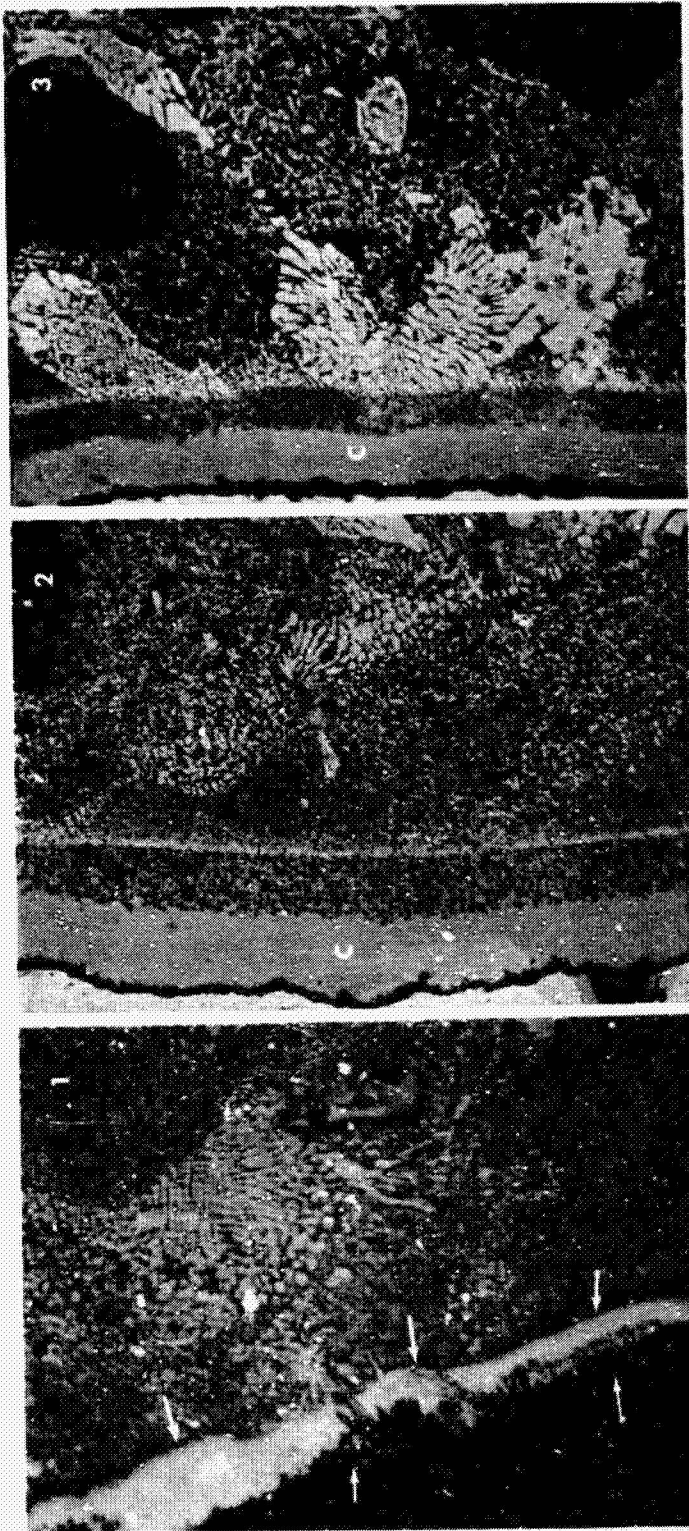
Figure 14. Representative Photomicrographs of DS MAR-M 200+Hf Blade S/N 13. The Numbers Denote Sections Indicated in Figure 12. Section 1 is Through the Tip-Rub Damage Area Shows Alloy Depletion and Oxidation; Section 2 Through the Mid-Span and Section 3 Through the Airfoil Base Show Normal Alloy and Coating Structures. The Letter C Denotes Coating (Etchant: Oxalic Acid) (Mag.: 500X)

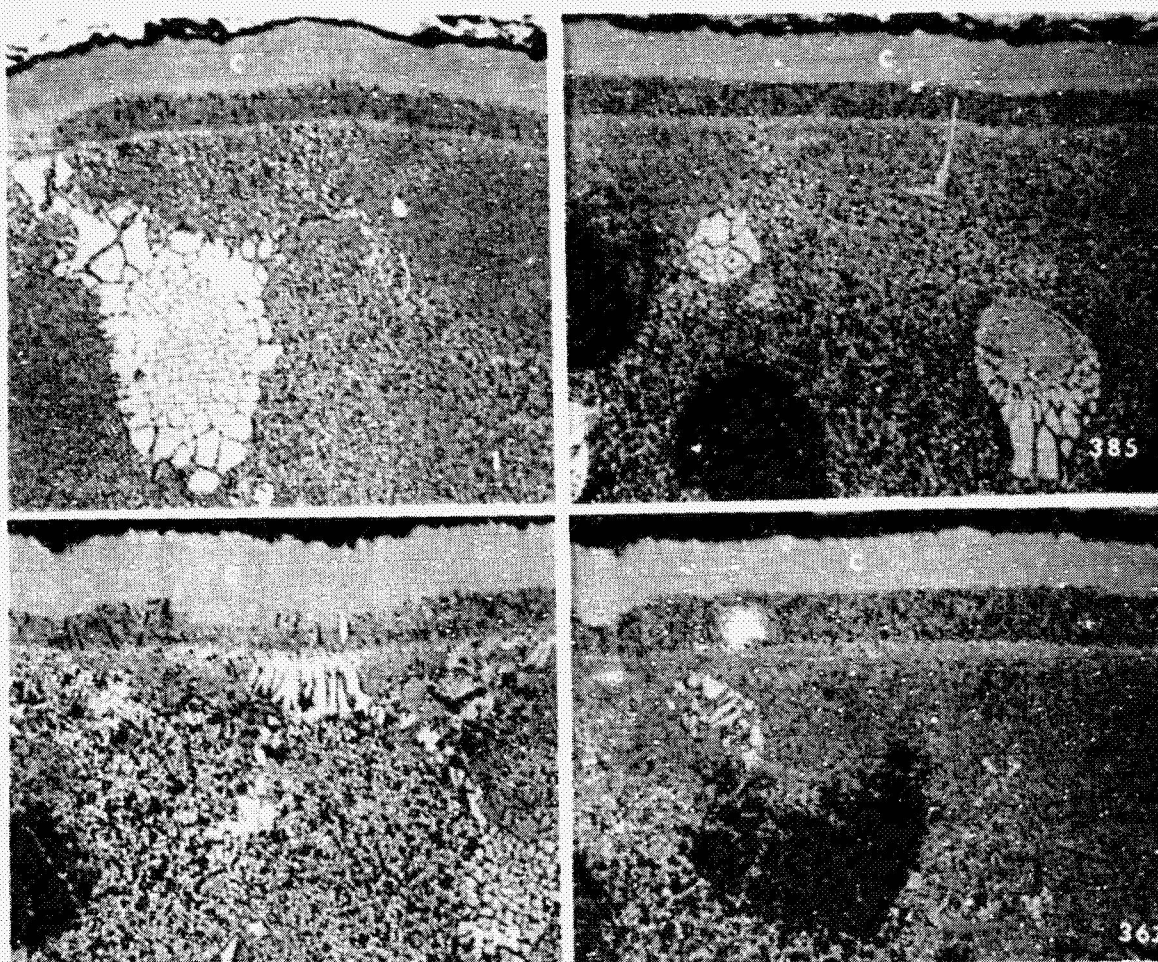
Figure 15. Representative Mid-Span Microstructures at Location 2 of Figure 12. Photos At Left Are MAR-M 200+Hf and the Photos At the Right Are MAR-M 247. The Letter C Denotes Coating. The Blade Serial Numbers Are At the Lower Right of Each Photo. No Abnormalities Were Found on These 50- and 100-Hour Test Blades (Etchant: Oxalic Acid) (Mag.: 500X)

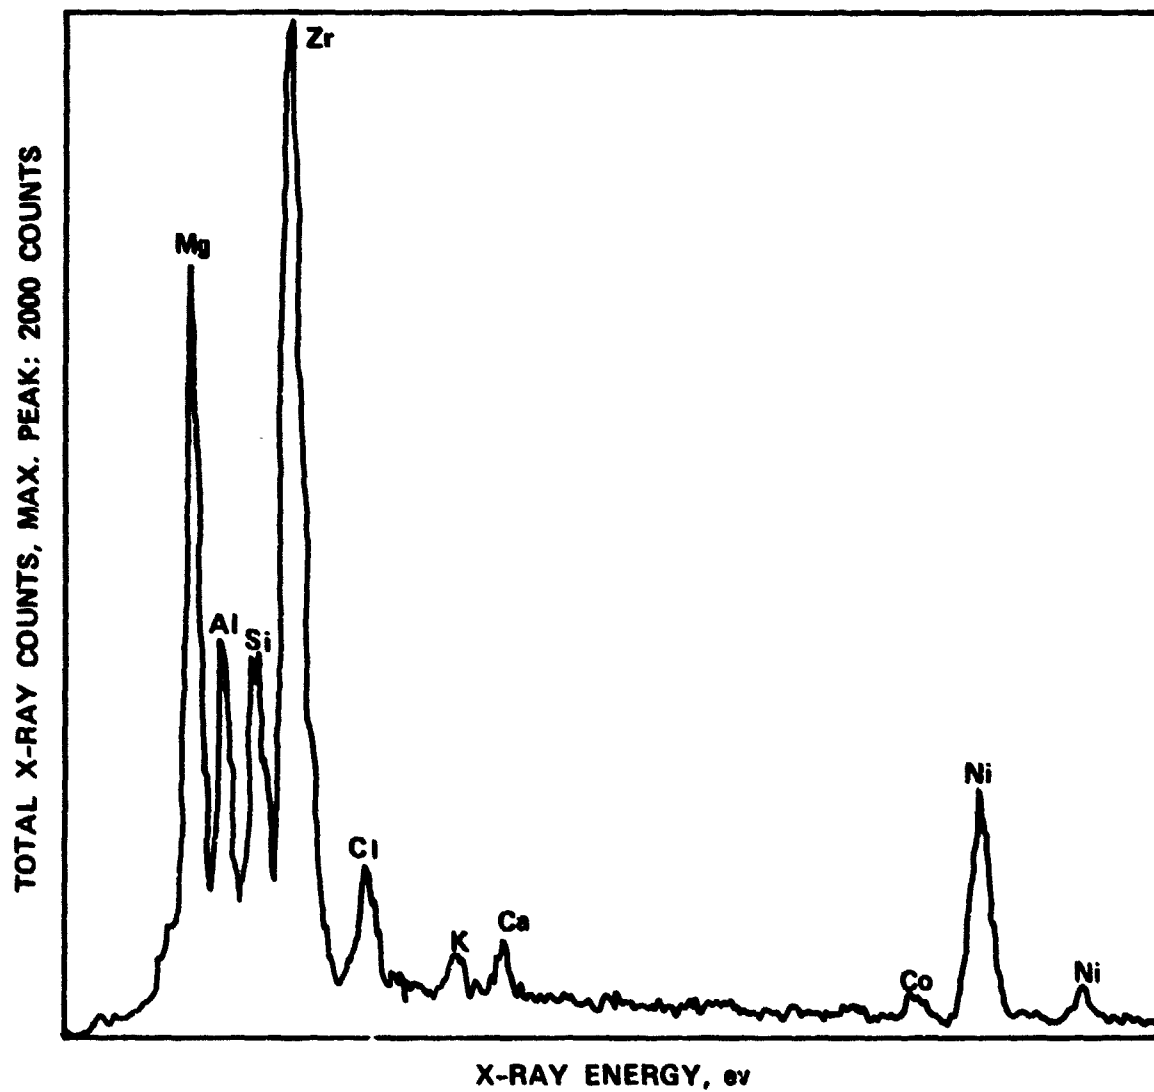
Figure 16. EDAX Analysis of the White Deposit on the Leading Edges of Blades S/N 13 and 341 as Shown in Figure 11
